SCREENING SITE INSPECTION REPORT
FOR

MACON COUNTY LANDFILL #2

DECATUR, ILLINOIS

DECEMBER 26, 1990

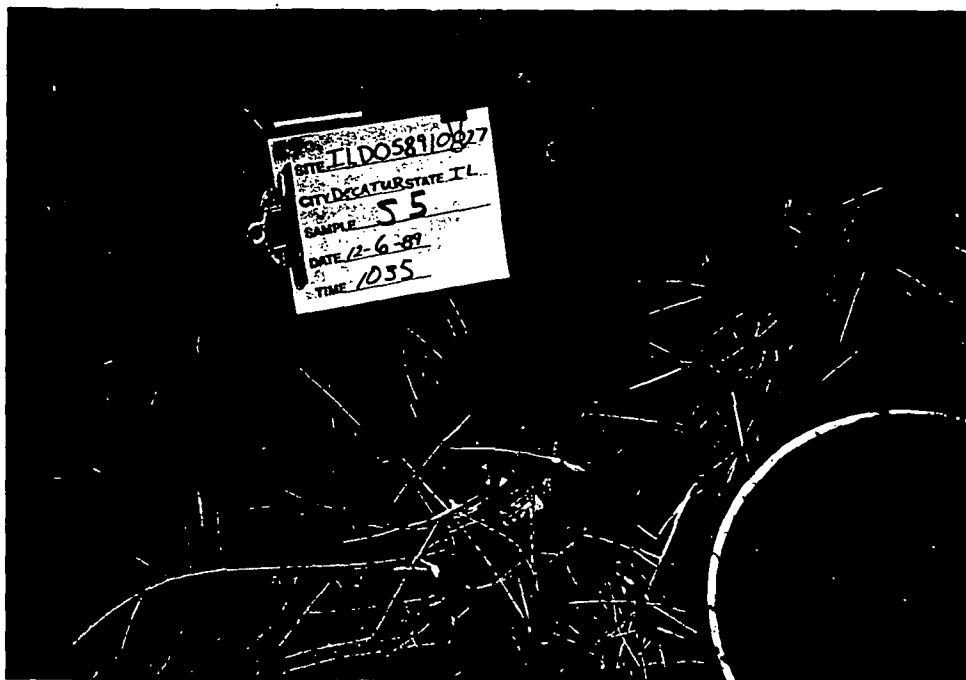
(if applicable): S5DESCRIPTION: Perspectiveview of soil samplelocation S5 near stormsewer drain.

(if applicable): S5DESCRIPTION: Close up view of soil sample location S5
near storm sewer drain.

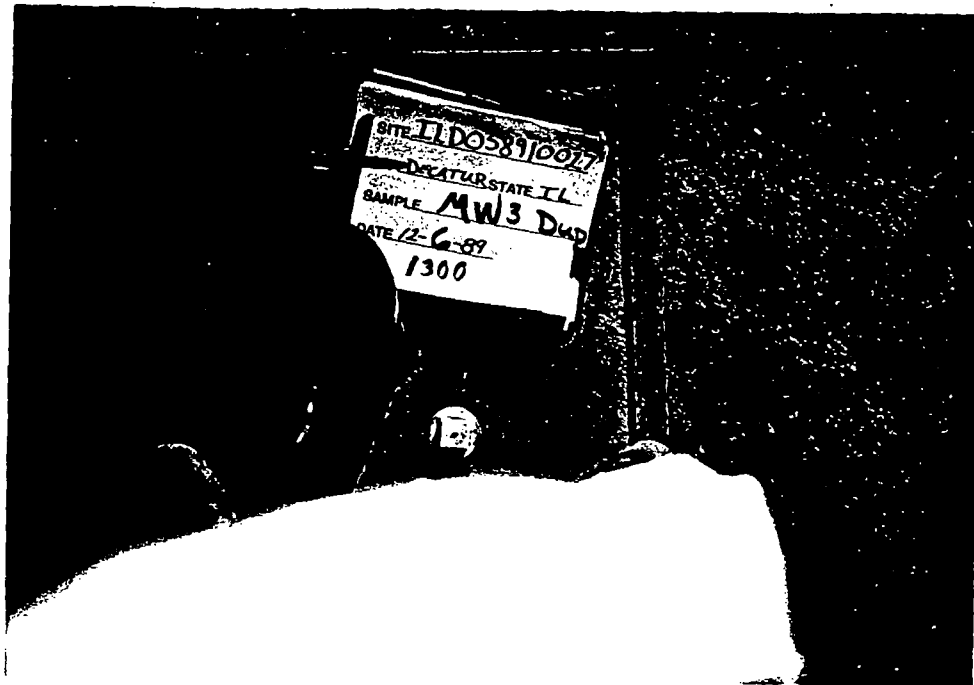
Sample MW2 was obtained from a well (G110) on the south end of the site. Sample MW2-A was also obtained at this location. Sample MW3 was obtained from a well (G111) at the southwest corner of the site. No corresponding sample could be obtained from well MW3 because of the removal of this well since the date of the original inspection. A replacement well for MW3 had not yet been installed.

DESCRIPTION: Close up view of monitor well sample location MW3DATE: 12/6/89TIME: 1340DIRECTION OF
PHOTOGRAPH:SWWEATHER
CONDITIONS:pt. cloudy~ 40°

DESCRIPTION: Perspective view of monitor well sample location MW3

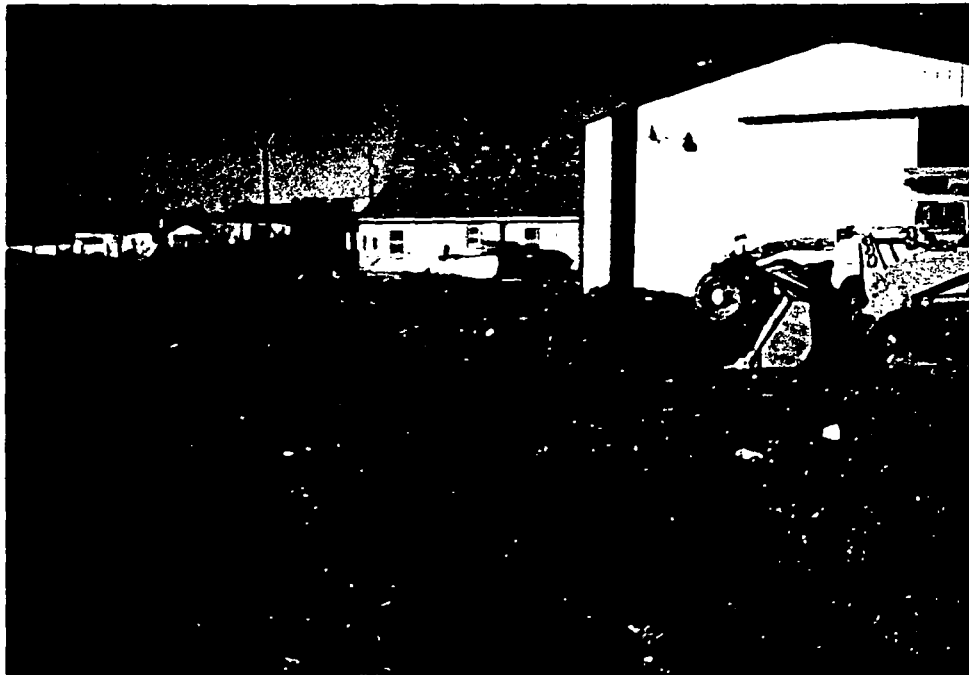
DESCRIPTION: Entrance to Macon County Landfill west of old
office building and present shop building.DATE: 12/6/89TIME: 1455DIRECTION OF
PHOTOGRAPH:
SWEATHER
CONDITIONS:
pt. cloudy ~40°PHOTOGRAPHED BY:
SAM BORRIESSAMPLE ID
(if applicable):
N/A

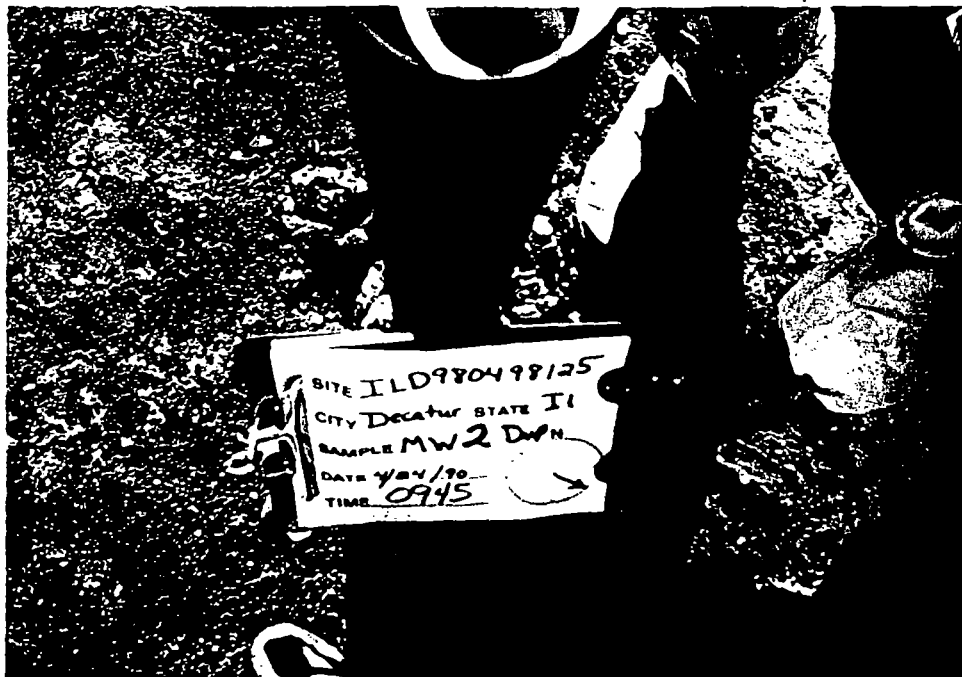
DESCRIPTION: Close up view of inorganic monitoring well sample
location MW2.DATE: 4/24/90TIME: 9:45DIRECTION OF
PHOTOGRAPH:Southeast

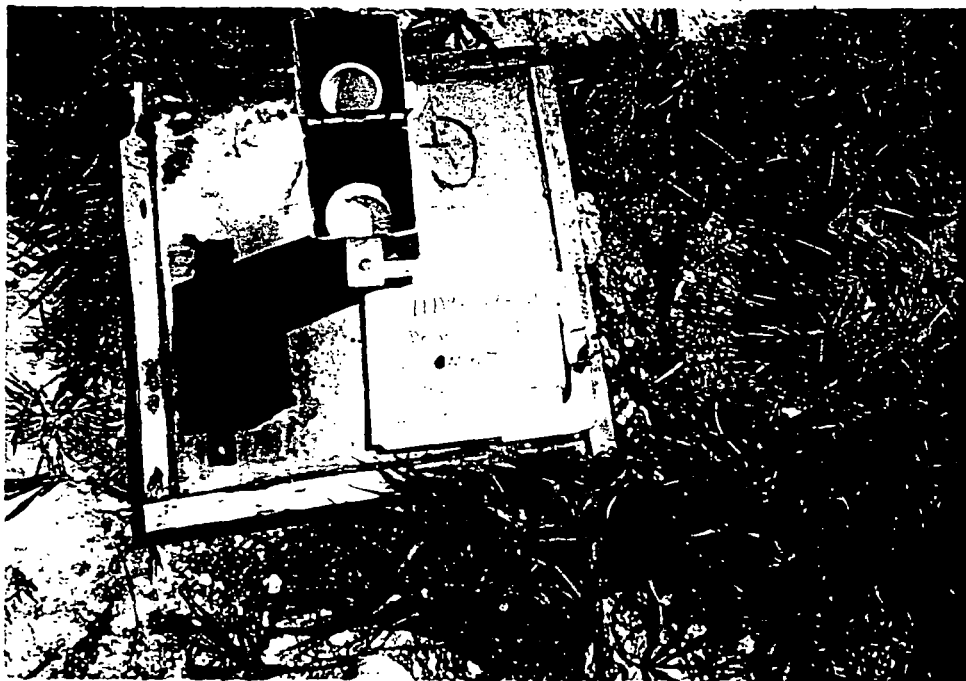
SITE NAME: MAcon County Landfill #2PAGE 25 OF 27U.S. EPA ID: ILD058910027 TOD: F05-8705-059PAN: FIL0557SADATE: 4/24/90TIME: 12:28DIRECTION OF
PHOTOGRAPH:
EastWEATHER
CONDITIONS:
Sunny ~75°PHOTOGRAPHED BY:
SAM BORRIESSAMPLE ID
(if applicable):
MW 4DESCRIPTION: Close up view of inorganic monitoring well sample
location MW 4.
